# Manhole Inspection Summary

Manhole # S33OO\_016MH

**Location** Address: **2325 MARYLAND AVE**

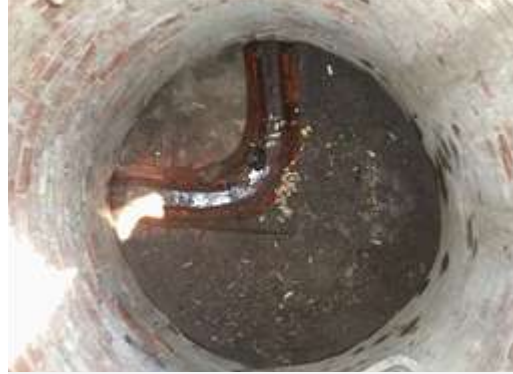
Top View

**Surcharge** ☒ **Evidence Of Surcharge** Depth: **1** (ft.) ☐ Active Surcharge Present

Evidence of surcharge - Bench debris.

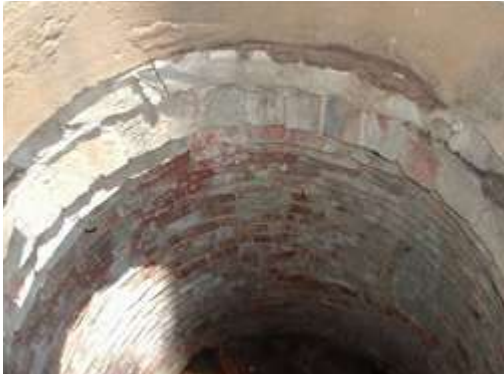
Defect

**Frame** Offset: **0** (in.) Condition: ☐ Sound ☐ Cracked ☒ **Leaks**

Condition: ☐ Sound ☐ Cracked ☐ Root Intrusion ☐ Loose Brick ☒ **Deteriorated**

Infiltration: ☐ None ☒ **Joint** ☐ Cracks ☐ Mortar ☐ Roots ☒ **Wall**

Infiltration: ☐ None ☐ Joint ☐ Cracks ☐ Mortar ☐ Roots ☒ **Wall**

Frame leaks. Adjustment deterioration and infiltration. Barrel infiltration - other side.

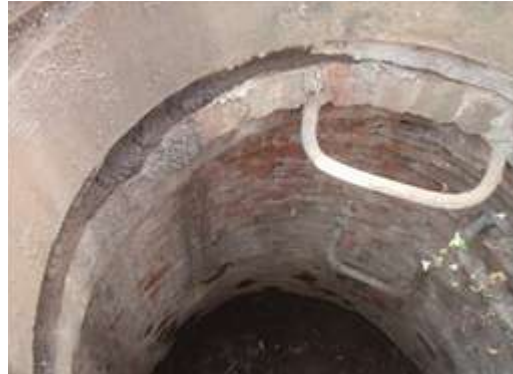
Defect

Frame leaks. Adjustment deterioration and infiltration. Barrel infiltration.
